RE: Structural Review Monterey School

edm Project No.: TOM-3839

As requested, a visual structural observation and review of the existing school building located in the Town of Monterey at 459 Main Street was conducted.

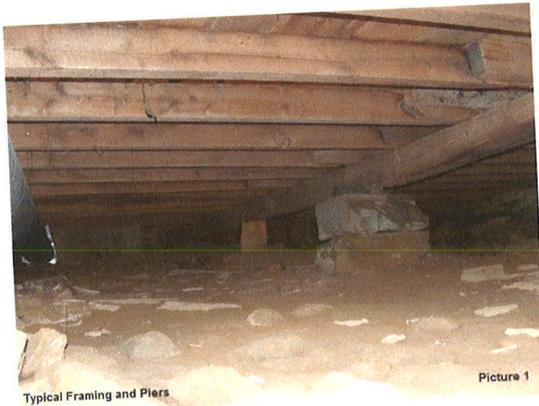
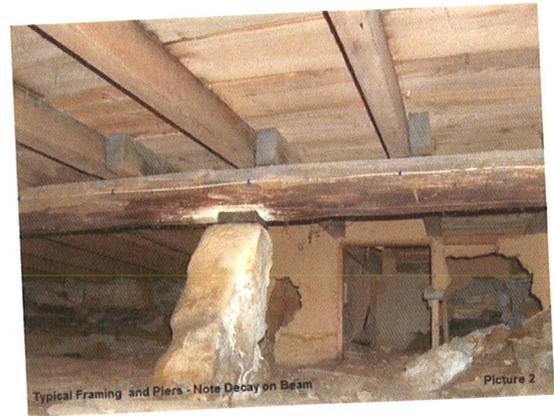
5. It was noted to be extremely damp in the crawl space below the building. See Pictures 1, 2, and 3. This should be addressed by increasing the ventilation of the crawl space area, and installing a layer of polyethylene on the crawl space floor (lapping and sealing joints of the polyethylene).

The opinion of probable cost for the moisture reduction in present dollars is approximately \$2,000 to \$3,000.

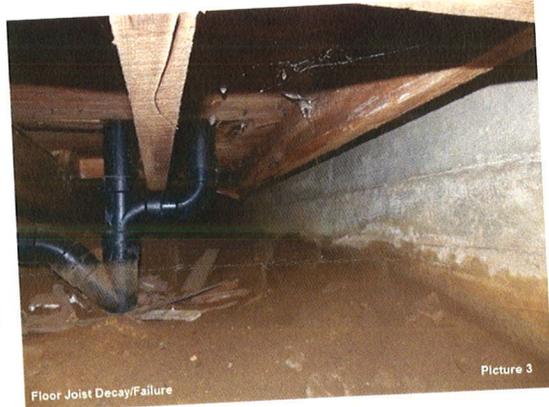
1. The existing first floor framing is failing in the bathroom area, located on the Northeast corner of the building addition. This failure appears to be caused by the decay of the floor joists along the North wall and has created a floor displacement greater than 3 inches. The floor framing repair should be implemented immediately if the school structure is to remain occupied.

The opinion of probable cost for the trim and sill beam repair in present dollars is approximately \$6,000 to \$7,000.

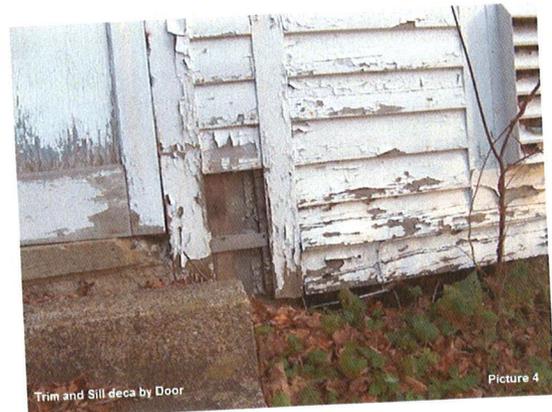
2. Exterior trim and sill beam decay was noted at the door and near the center of the building along the West side. The exterior trim pieces should be replaced within the next year to limit water infiltration into the sill beam. The sill beam should be repaired within the next two to five years. The urgency of this replacement will increase as the sill beam continues to decay.

The opinion of probable cost for the trim and sill beam repair in present dollars is approximately \$4,000 to \$5,000.

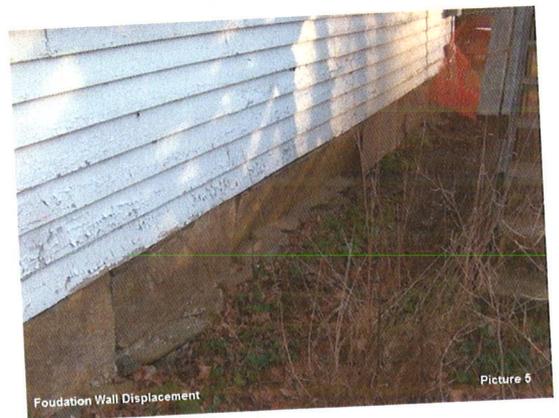
3. Along the West side, the foundation masonry has been displaced. It is recommended that the foundation wall be repaired and realigned within the next three to five years.

The opinion of probable cost for the foundation repair in present dollars is approximately \$5,000 to \$6,000.

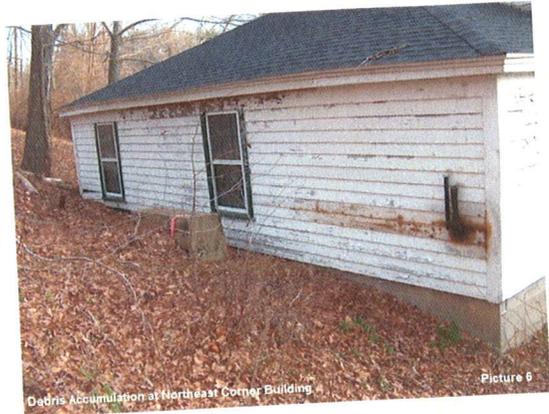
4. Excessive debris has accumulated along the North side of the building. This debris creates the potential for water damage to the building and building structure along the North side. It is recommended that the debris be removed from along the building within the next year and debris cleaning should be performed on an annual basis.

The opinion of probable cost for the removing the accumulated debris in present dollars is approximately \$200.
