Town Hall Culvert – Route 23/Main Street

Courteny Morehouse
Berkshire Regional Planning Commission

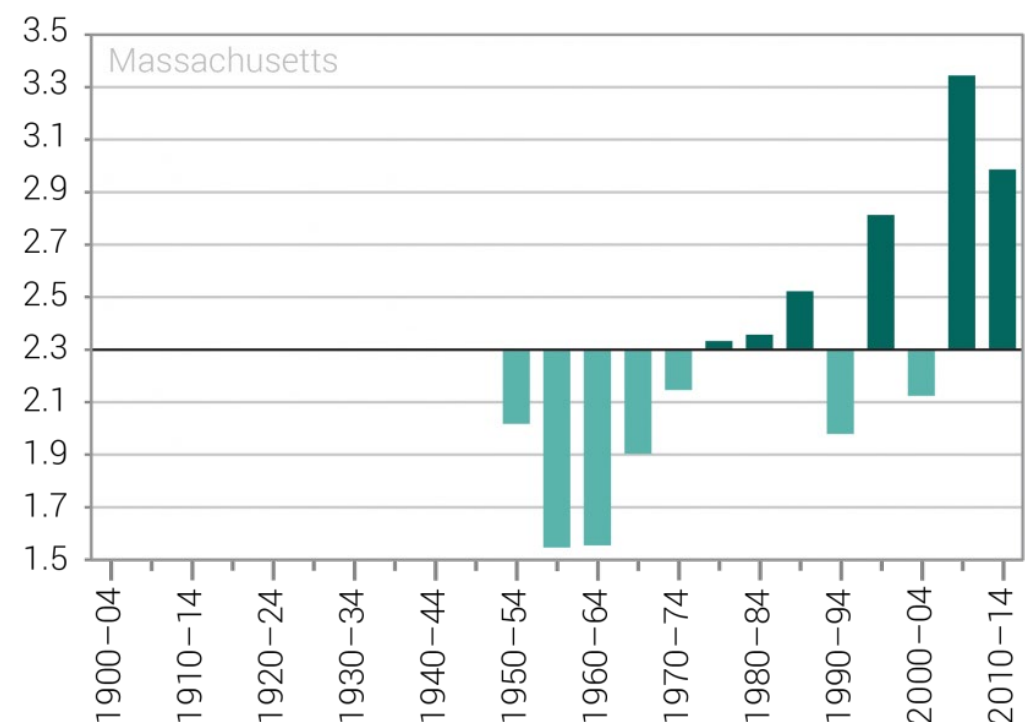
Increased # of precipitation events since 1970s

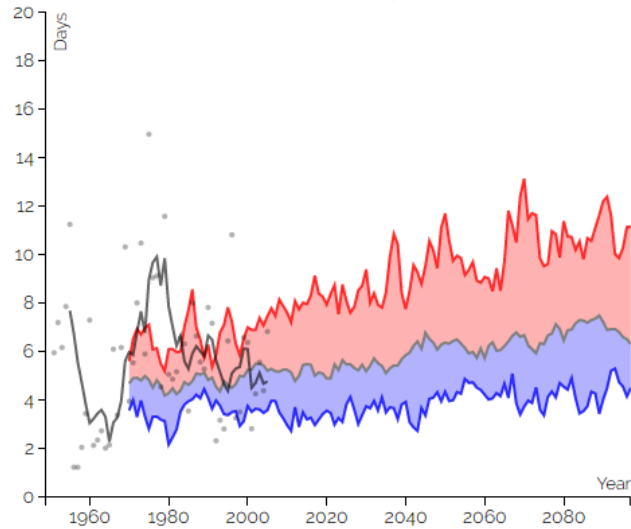
Annual Days with Precipitation > 1"
Berkshire County, MA

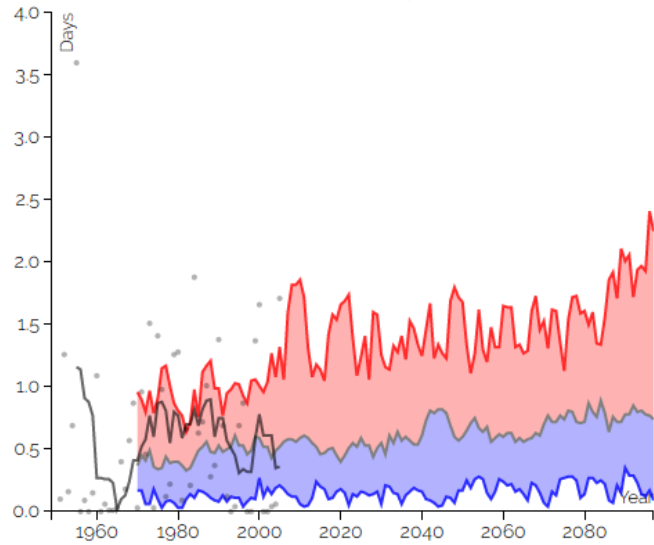
Annual Days with Precipitation > 2"
Berkshire County, MA

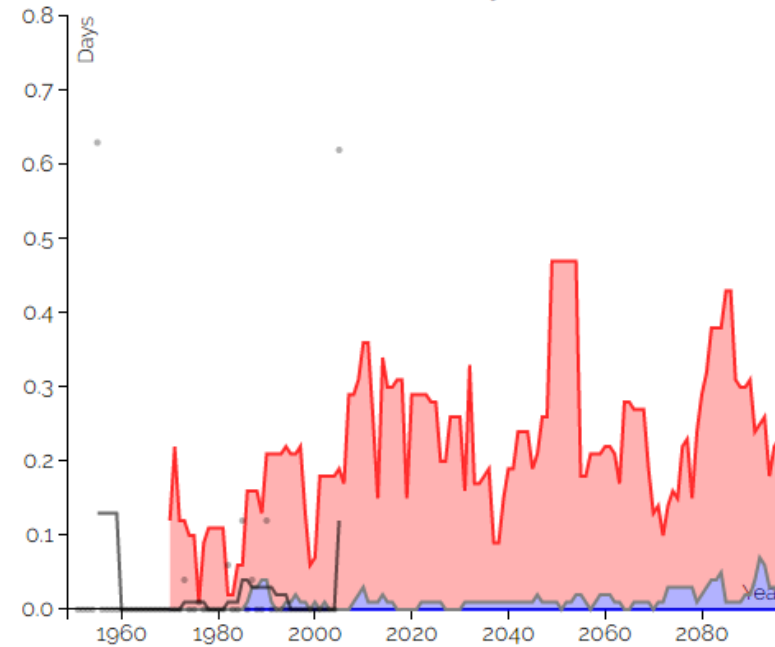
Annual Days with Precipitation > 4"
Berkshire County, MA

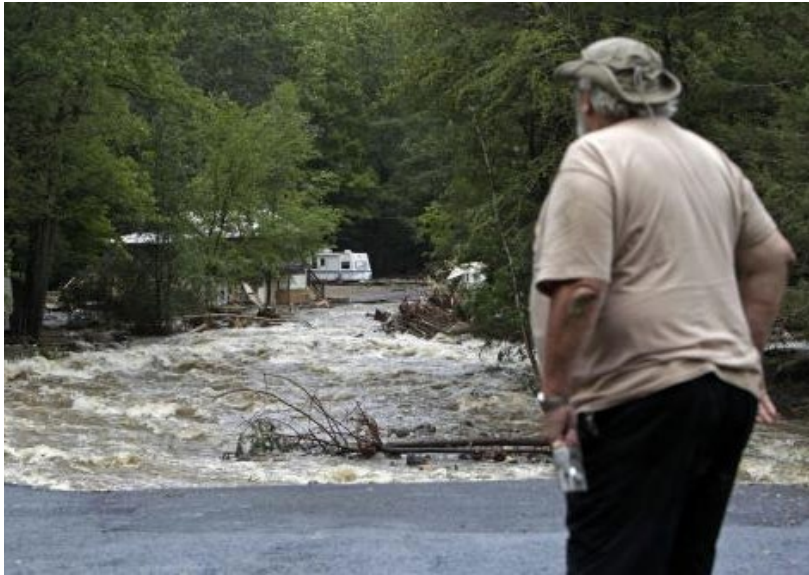
Flooding of Walker Brook
Campground in Chester, MA

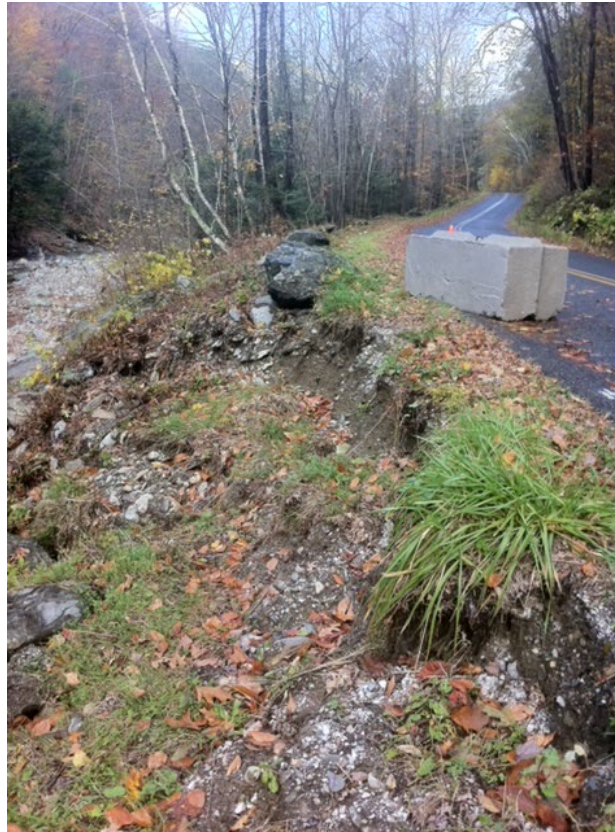
Fall Rd in Mt. Washington
after Hurricane Irene

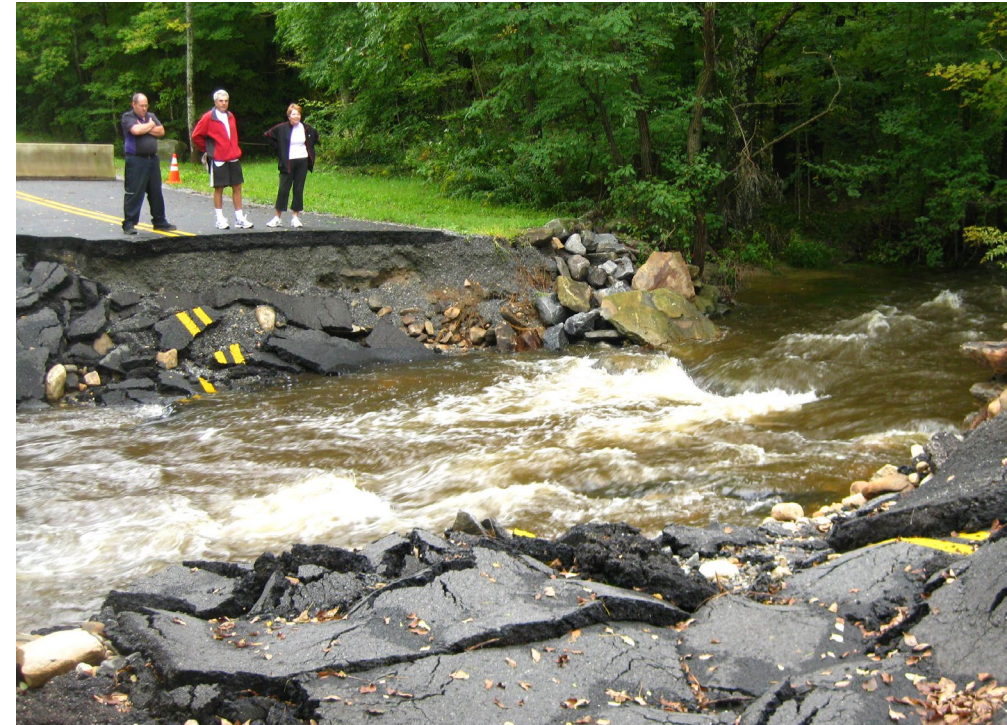
Failure of Benton Hill Culvert

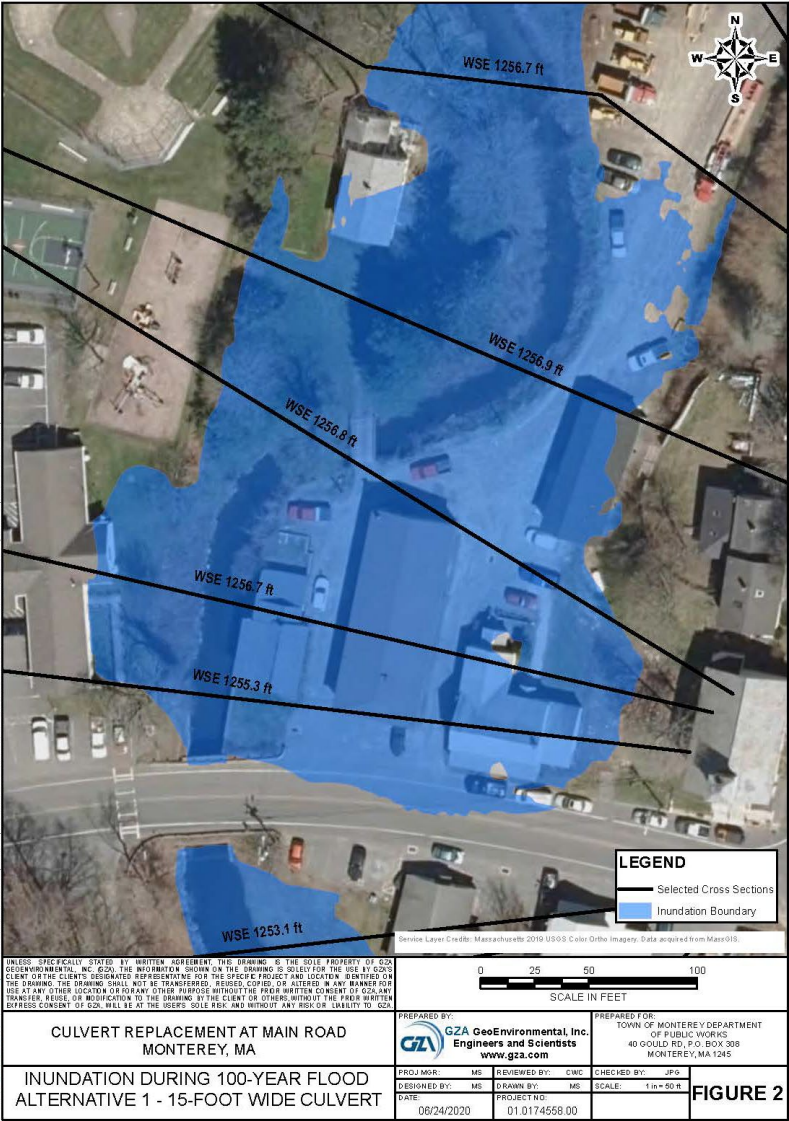
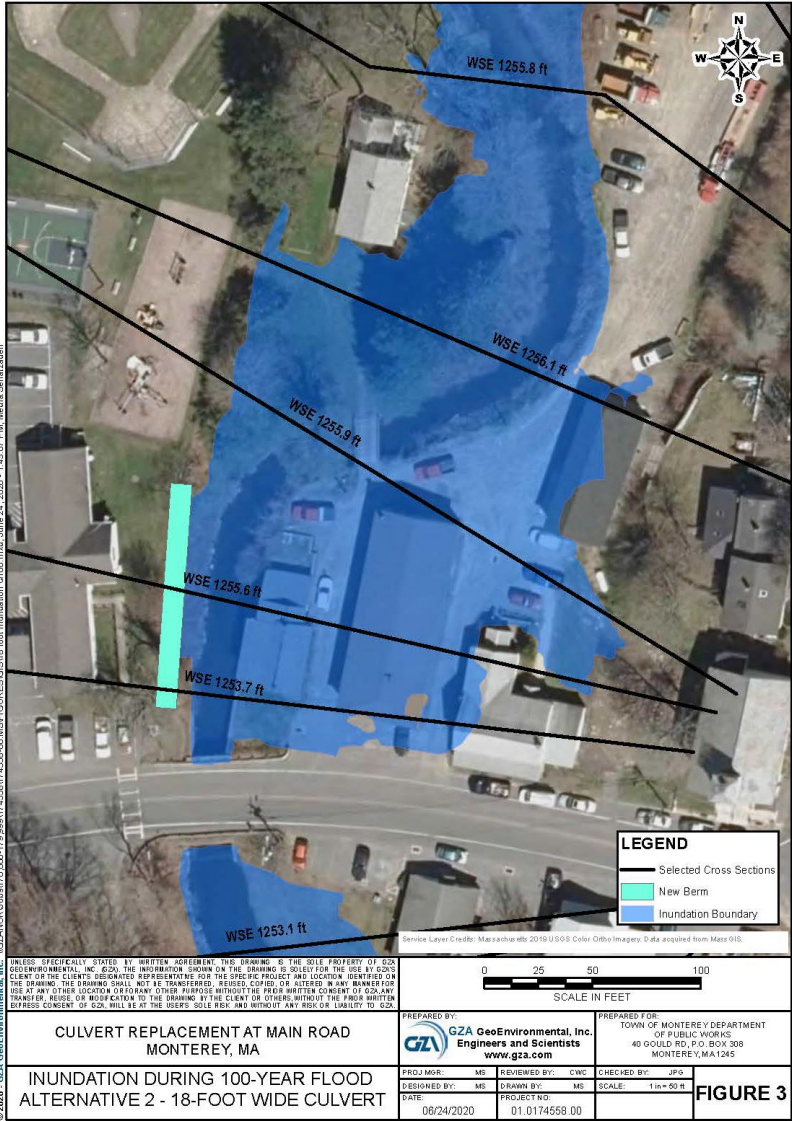
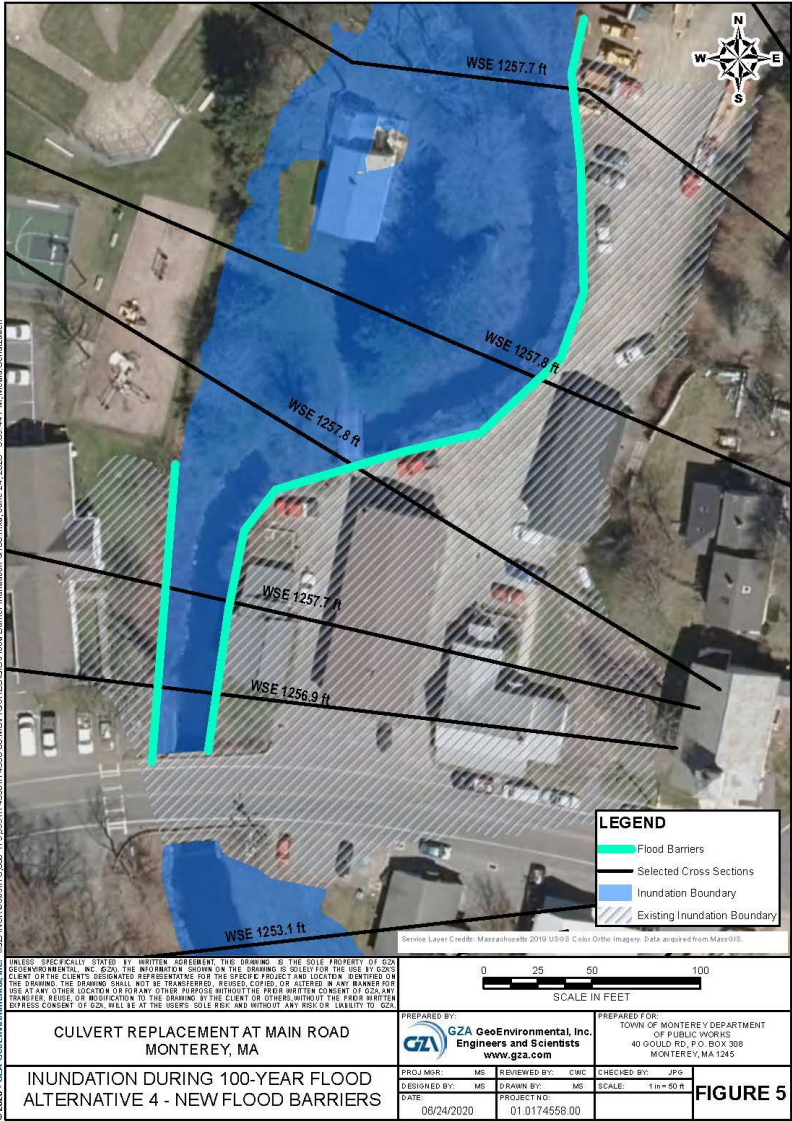
Alternatives Explored

Estimate Cost: \$1.35 Million

Estimate Cost: \$2.1 Million

Estimate Cost: \$1.17 Million

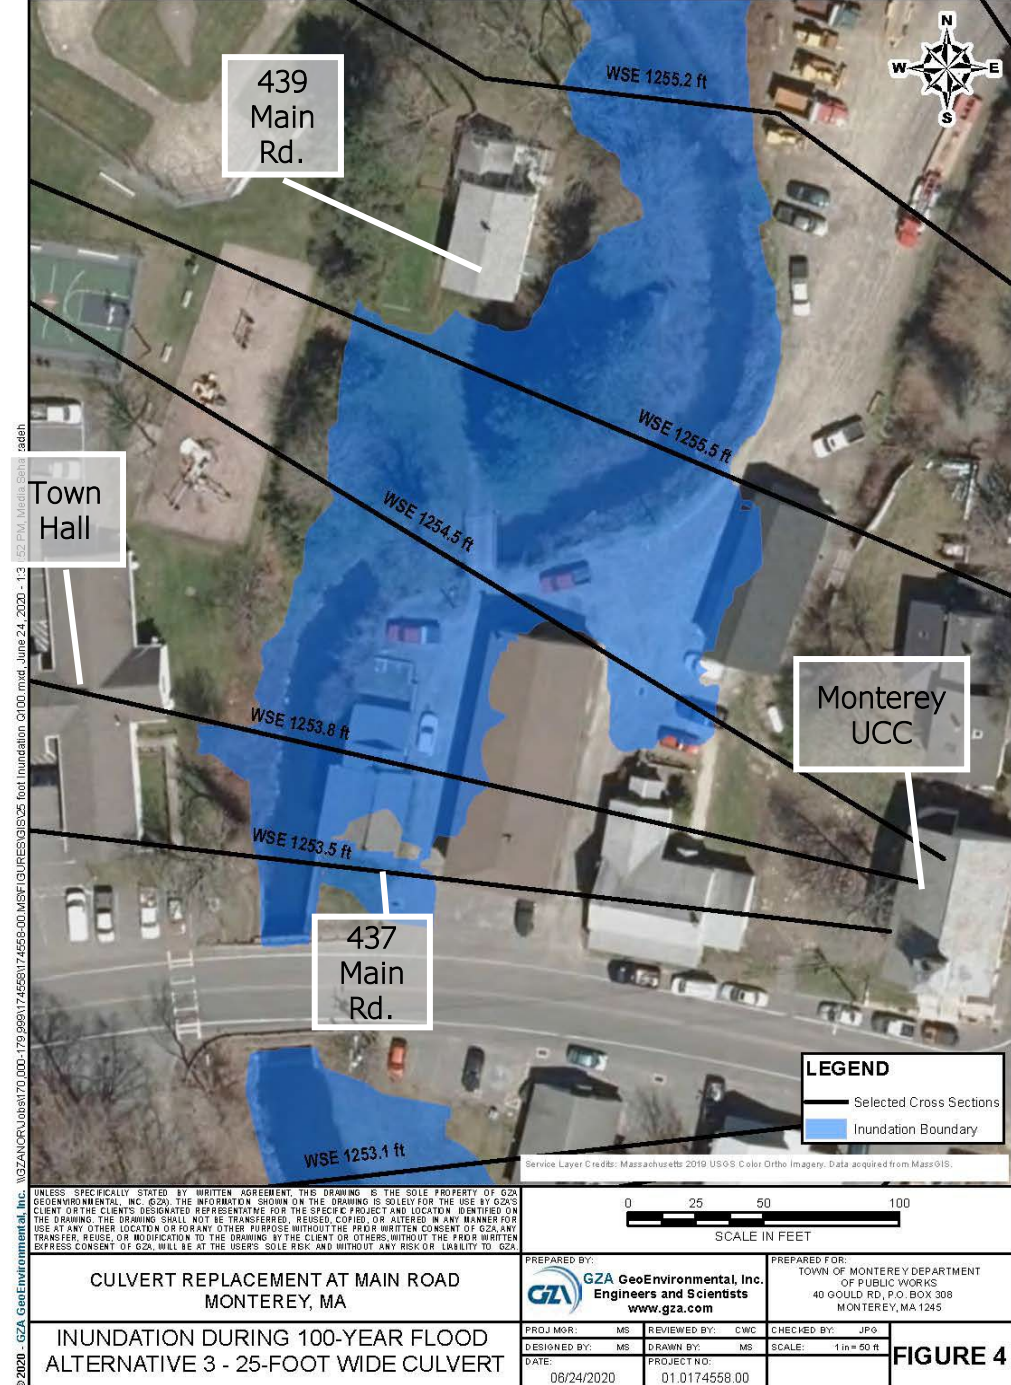
25' Culvert Replacement – Inundation during 100- year storm

Estimate Cost:
\$2.4 Million
